**Flood Control Project Maintenance
Levee Inspections**

Fall 2011 Levee Maintenance Deficiency Summary Report

Reclamation District No. 2094 Wathal

Waterway			Bank	Unit Miles
Unit No. 01 San Joaquin River			Right	2.82
	Spring (March - May)	Summer (June - August)	(September - November) Fall	Winter (December - February)
Unit Maintenance Rating (Fall Only)			A	
Date of Inspection	4/12/2011 - 4/12/2011		11/9/2011 - 11/9/2011	
DWR Inspector	Jim Eto		Jim Eto	
Accompanied By	Brian Mizuno RD 2094		Brian Mizuno RD 2094

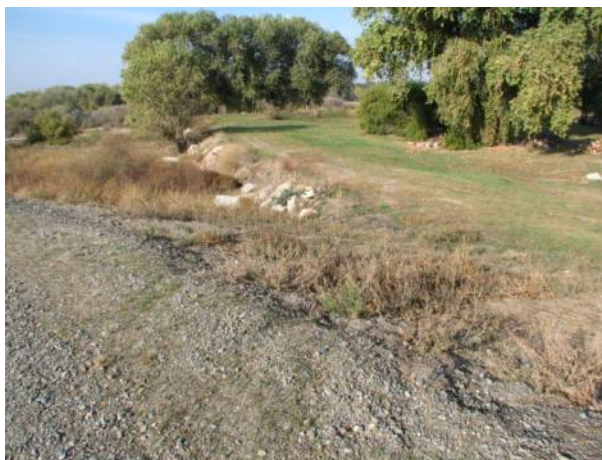
Levee Mile Report Line	1
Start Levee Mile	0.10
End Levee Mile	0.10
Location	Water Side
Category	Earthen Levee
Item	Encroachments

LMR No.	Levee Mile		Category	Item	Location *	Rating **	Action/Comment	GPS Latitude/Longitude		Issue No. Photo
	Start	End						Start	End	
1	0.10	0.10	Earthen Levee	Encroachments	WS	PO	Ramp Inspector Comments: An access ramp has been built on the water side and extends into the channel. This could potentially alter the channel capacity. This item was also noted in the USACE comments.	37.771685 ° -121.300239 °	37.771685 ° -121.300239 °	4 Y
2	0.54	0.54	Earthen Levee	Seepage / Sandboils	LS	C	Inspector Comments: Seepage areas noted. No boils present	37.768451 ° -121.296491 °	37.768451 ° -121.296491 °	8
3	0.66	0.66	Earthen Levee	Encroachments	WS	W	Pipe Inspector Comments: 14" steel irrigation intake with sluice gate.	37.767505 ° -121.294902 °	37.767505 ° -121.294902 °	1 Y
4	0.86	1.42	Earthen Levee	Seepage / Sandboils	LS	C	Inspector Comments: Lengthy seepage area noted, evidence of wet soil and standing water. No boils present.	37.764885 ° -121.293350 °	37.759007 ° -121.299725 °	9

11/09/2011 Tire marks shown onto ramp from levee. Raised area extends to the trees in the background in the center of the photo.

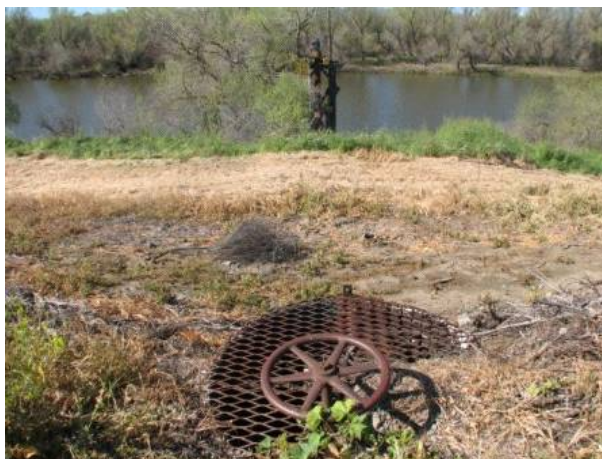
Levee Mile Report Line	3
Start Levee Mile	0.66
End Levee Mile	0.66
Location	Water Side
Category	Earthen Levee
Item	Encroachments

Irrigation intake on San Joaquin River. Positive closure device (sliuce gate) on water side hinge points. Pipe is through freeboard portion of levee. Concrete stand pipe beyond landside toe.

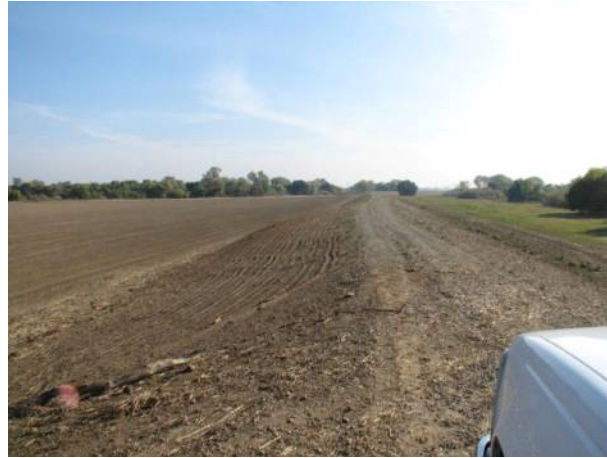
Levee Mile Report Line	1
Start Levee Mile	0.01
End Levee Mile	0.45
Location	
Category	Earthen Levee
Item	Vegetation

LMR No.	Levee Mile		Category	Item	Location *	Rating **	Action/Comment	GPS Latitude/Longitude		Issue No. Photo
	Start	End						Start	End	
1	0.01	0.45	Earthen Levee	Vegetation		A	Remove the wild growth other than native grasses from the levee slopes. Inspector Comments: Levee is clean and free of vegetation,	37.759274 ° -121.299777 °	37.760612 ° -121.307076 °	8 Y

11/09/2011 Levee is clean and free of vegetation.
